**Flood Control Project Maintenance
Levee Inspections****LMA District Cover Sheet
Spring 2014 Levee Inspection Results****Yolo County Planning Resources and Public Works**

Spring 2014 Levee Inspection Results

Yolo County Planning Resources and Public Works

Waterway			Bank	Unit Miles
Unit No. 01 Right Bank Cache Creek			Right	0.29
	Spring (March - May)	Summer (June - August)	(September - November) Fall	Winter (December - February)
Unit Maintenance Rating (Fall Only)				
Date of Inspection	03/18/2014 - 03/18/2014			
DWR Inspector	John Williamson			
Accompanied By

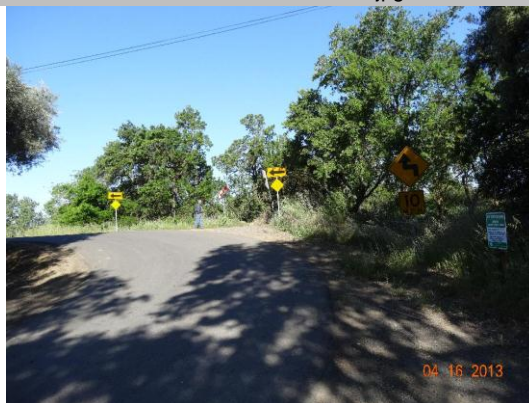
Photo 1 of 1 : UCIP_484.jpg

LM Start	0.00	Rating **	M	Issue No.	2
LM End	0.00	Issue Type +	En	Location *	LS
Category	Supplemental			GPS Latitude/Longitude	
				Start	End
Item	DWR UCIP Field Study			38.722162 °	38.722162 °
				-121.807223 °	-121.807223 °
DWR ID	DWR_NA0021_01_s_2014_2				
Action/Comments					
Inspector Comments: FS_ID:11657					
EP_NO: 6790					
Repair Type:					
Crossing Status:					
UCIP Comments:					
FIELD_STRUCT_DESC: 6-inch gas line through levee, 4-feet below the crown. Pipe extends from borrow area and under the channel. Bleeder valve on waterward bank. Service vault located on landward side next to access gate. Paved access ramp on landward slope. (Permit No. 6790-1970)					
FS Date: 4/16/2013

View of gas line marker located on levee crown.

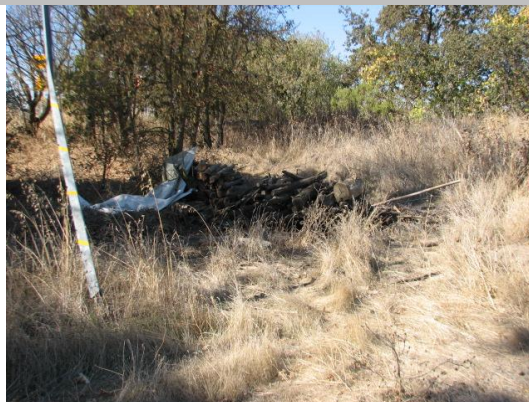
Photo 1 of 2 : johngw_s_20140306_791.jpg

LM Start	0.00	Rating **	M	Issue No.	3
LM End	0.00	Issue Type +	Ma	Location *	WS
Category	Earthen Levee			GPS Latitude/Longitude	
				Start	End
Item	Encroachments			38.722220 °	38.722220 °
				-121.806965 °	-121.806965 °
DWR ID	DWR_NA0021_01_s_2012_3				
Action/Comments					
Firewood

Firewood is stacked on the waterside of the levee. Fall 2013

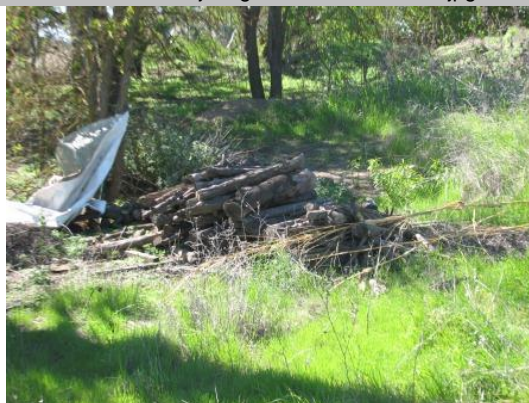
Photo 2 of 2 : johngw_s_20140324_666.jpg

LM Start	0.00	Rating **	M	Issue No.	3 (cont)	
LM End	0.00	Issue Type +	Ma	Location *	WS	
Category	Earthen Levee			GPS Latitude/Longitude		
				Start		End
Item	Encroachments			38.722220 °	38.722220 °	
				-121.806965 °	-121.806965 °	
DWR ID	DWR_NA0021_01_s_2012_3					
Action/Comments						
Firewood

Firewood is still on the slope. Spring 2014

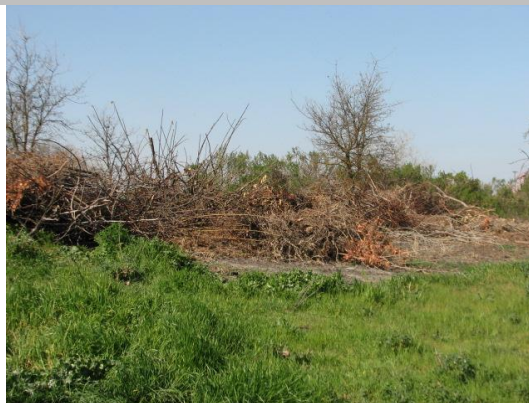
Photo 1 of 3 : johngw_s_20140306_792.jpg

LM Start	0.01	Rating **	M	Issue No.	4
LM End	0.01	Issue Type +	En	Location *	WS
Category	Earthen Levee			GPS Latitude/Longitude	
				Start	End
Item	Encroachments			38.722418 °	38.722418 °
				-121.806999 °	-121.806999 °
DWR ID	DWR_NA0021_01_s_2012_4				
Action/Comments					
Prunings

A continuous brush pile on levee. Spring 2013

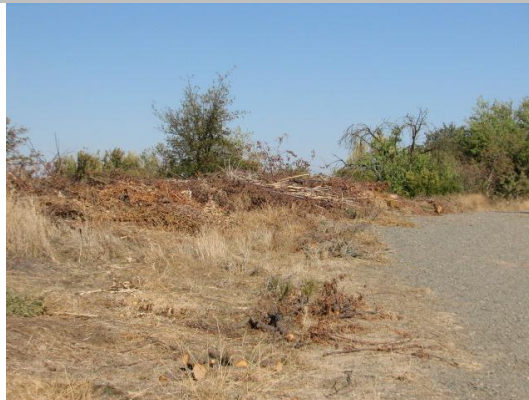
Photo 2 of 3 : johngw_s_20140306_793.jpg

The latest look of the on going brush pile. Fall 2013

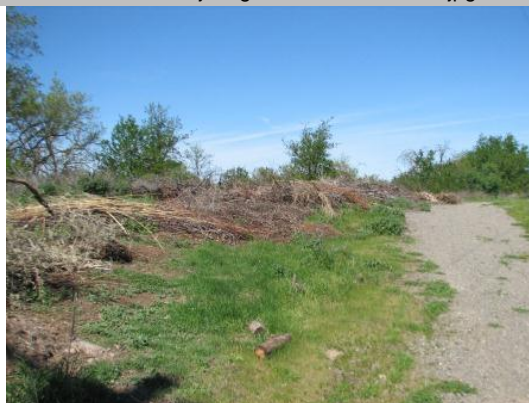
Photo 3 of 3 : johngw_s_20140324_667.jpg

LM Start	0.01	Rating **	M	Issue No.	4 (cont)	
LM End	0.01	Issue Type +	En	Location *	WS	
Category	Earthen Levee			GPS Latitude/Longitude		
				Start		End
Item	Encroachments			38.722418 °	38.722418 °	
				-121.806999 °	-121.806999 °	
DWR ID	DWR_NA0021_01_s _ 2012_4					
Action/Comments						
Prunings

The brush pile did not get burned this last winter. Spring 2014

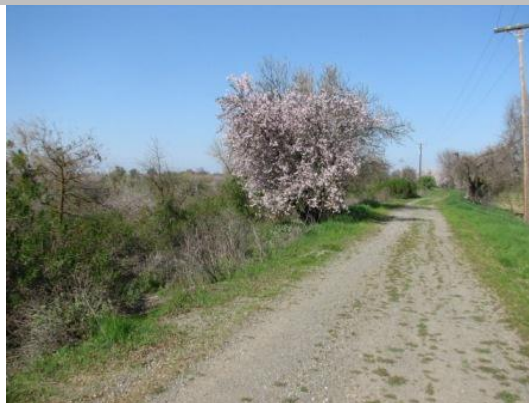
Photo 1 of 3 : johngw_s_20140306_800.jpg

Vegetation and brush is taller than 12 inches. No visibility of the waterside berm. Spring 2013

LM Start	0.01	Rating **	U	Issue No.	17
LM End	0.26	Issue Type +	Ma	Location *	WS
Category	Earthen Levee			GPS Latitude/Longitude	
				Start	End
Item	Vegetation			38.722220 °	38.725887 °
				-121.806966 °	-121.806550 °
DWR ID	DWR_NA0021_01_s _ 2012_17				
Action/Comments					
Remove the wild growth other than native grasses from the levee slopes.

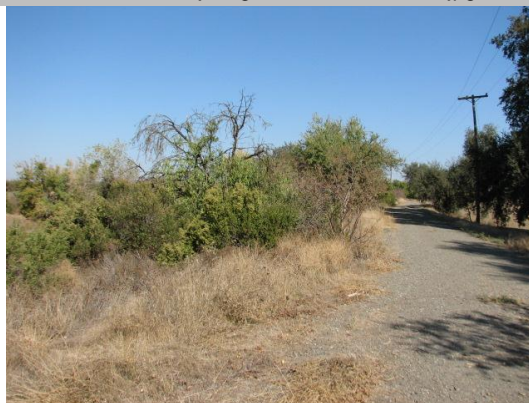
Photo 2 of 3 : johngw_s_20140306_801.jpg

The vegetation on the waterside is over grown. Fall 2013

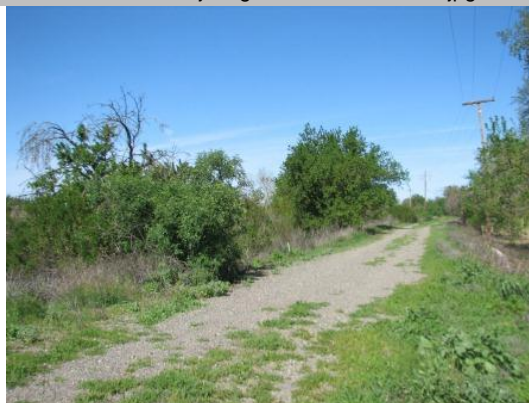
Photo 3 of 3 : johngw_s_20140324_668.jpg

Tall grasses and brush on the waterside berm area. Spring 2014

LM Start	0.01	Rating **	U	Issue No.	17 (cont)	
LM End	0.26	Issue Type +	Ma	Location *	WS	
Category	Earthen Levee			GPS Latitude/Longitude		
				Start	End	
Item	Vegetation			38.722220 °	38.725887 °	
				-121.806966 °	-121.806550 °	
DWR ID	DWR_NA0021_01_s _ 2012_17					
Action/Comments						
Remove the wild growth other than native grasses from the levee

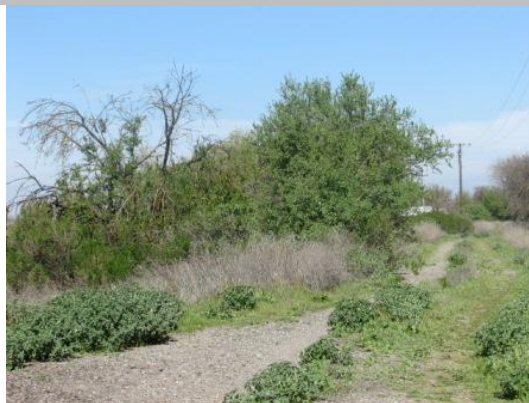
Photo 1 of 1 : johngw_s_20140306_799.jpg

LM Start	0.03	Rating **	A/W	Issue No.	14
LM End	0.03	Issue Type +	Ma	Location *	WS
Category	Earthen Levee			GPS Latitude/Longitude	
				Start	End
Item	Vegetation			38.722633 °	38.722633 °
				-121.806938 °	-121.806938 °
DWR ID	DWR_NA0021_01_s _ 2012_14				
Action/Comments					
Elderberries are blocking visibility and flood fight capability.

Photo taken spring 2012, a large Elderberry on the waterside.

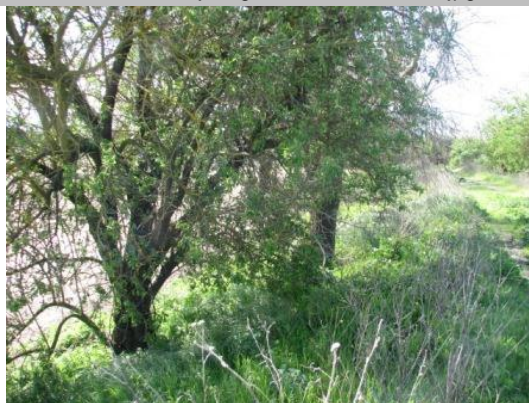
Photo 1 of 1 : johngw_s_20140306_802.jpg

The trees need to be thinned and trimmed up for visibility.

LM Start	0.03	Rating **	M	Issue No.	19
LM End	0.06	Issue Type +	Ma	Location *	LS
Category	Earthen Levee			GPS Latitude/Longitude	
				Start	End
Item	Trim / Thin Trees			38.722699 °	38.723001 °
				-121.806920 °	-121.806864 °
DWR ID	DWR_NA0021_01_s _ 2012_19				
Action/Comments					
Trim and thin trees to allow visibility of the ground and room to flood fight.

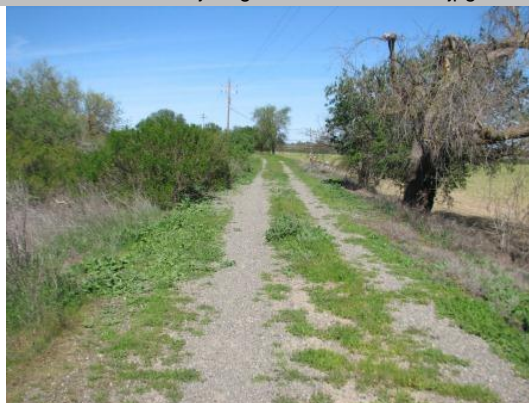
Photo 1 of 1 : johngw_s_20140324_669.jpg

Vegetation on the crown needs to be controlled. Spring 2014

LM Start	0.06	Rating **	M	Issue No.	13
LM End	0.26	Issue Type +	Ma	Location *	CR
Category	Earthen Levee			GPS Latitude/Longitude	
				Start	End
Item	Vegetation			38.723017 °	38.725844 °
				-121.806879 °	-121.806516 °
DWR ID	DWR_NA0021_01_s_2014_13				
Action/Comments					
Keep the crown roadway free of vegetation.

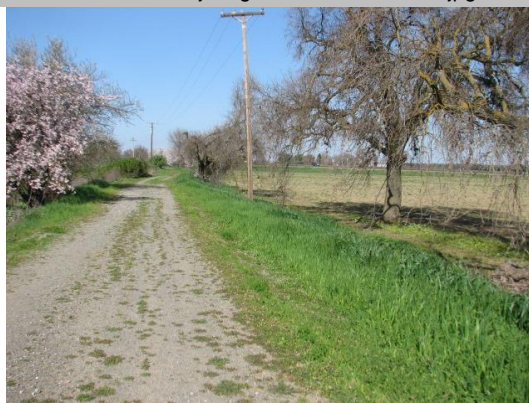
Photo 1 of 2 : johngw_s_20140306_789.jpg

Vegetation needs to be mowed taller than 12". Spring 2013

LM Start	0.08	Rating **	M	Issue No.	1
LM End	0.26	Issue Type +	Ma	Location *	LS
Category	Earthen Levee			GPS Latitude/Longitude	
				Start	End
Item	Vegetation			38.723381 °	38.725835 °
				-121.806786 °	-121.806526 °
DWR ID	DWR_NA0021_01_s_2012_1				
Action/Comments					
Remove the wild growth other than native grasses from the levee slopes.					
Inspector Comments: This area now has been declared a habitat restoration area by the Cache Creek Conservancy.

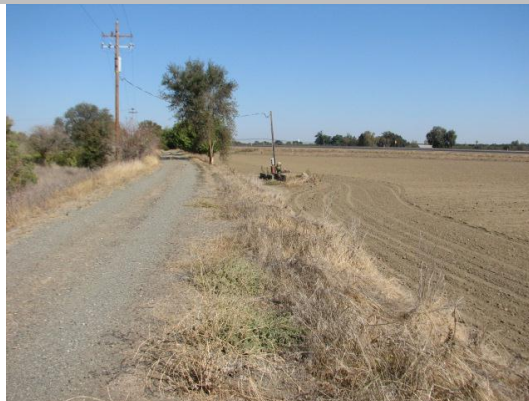
Photo 2 of 2 : johngw_s_20140306_790.jpg

The vegetation partially blocking visibility. Fall 2013

LM Start	0.08	Rating **	M	Issue No.	1 (cont)	
LM End	0.26	Issue Type +	Ma	Location *	LS	
Category	Earthen Levee			GPS Latitude/Longitude		
				Start	End	
Item	Vegetation			38.723381 °	38.725835 °	
				-121.806786 °	-121.806526 °	
DWR ID	DWR_NA0021_01_s _ 2012_1					
Action/Comments						
Remove the wild growth other than native grasses from the levee slopes. Inspector Comments: This area now has been declared a habitat restoration area by the Cache Creek Conservancy.

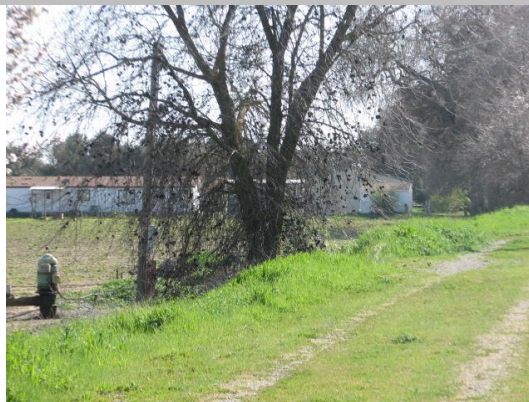
Photo 1 of 1 : johngw_s_20140306_794.jpg

Tree needs to be trimmed up 5'. Spring 2013

LM Start	0.13	Rating **	M	Issue No.	6
LM End	0.13	Issue Type +	Ma	Location *	LS
Category	Earthen Levee			GPS Latitude/Longitude	
				Start	End
Item	Trim / Thin Trees			38.723903 °	38.723903 °
				-121.806613 °	-121.806613 °
DWR ID	DWR_NA0021_01_s _ 2012_6				
Action/Comments					
Trim trees to at least five feet above ground level.

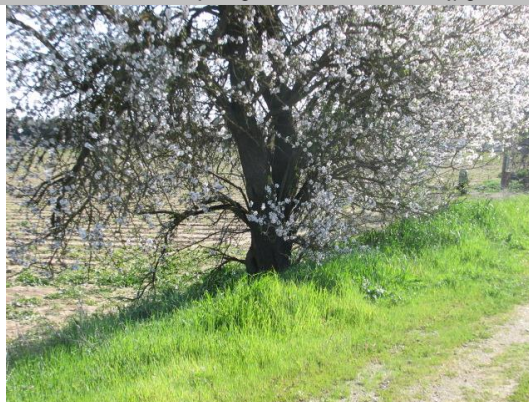
Photo 1 of 1 : johngw_s_20140306_795.jpg

Tree needs to be trimmed to 5'. Spring 2013

LM Start	0.15	Rating **	M	Issue No.	7
LM End	0.15	Issue Type +	Ma	Location *	LS
Category	Earthen Levee			GPS Latitude/Longitude	
				Start	End
Item	Trim / Thin Trees			38.724165 °	38.724165 °
				-121.806552 °	-121.806552 °
DWR ID	DWR_NA0021_01_s _ 2012_7				
Action/Comments					
Trim trees to at least five feet above ground level.

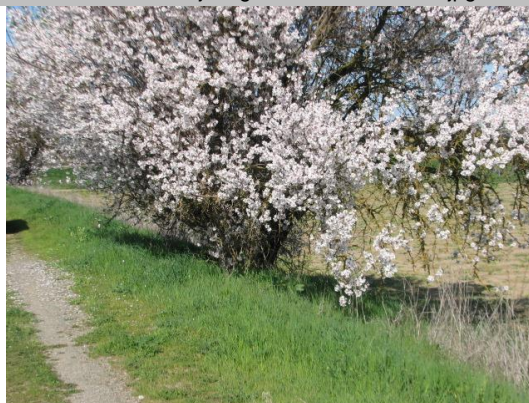
Photo 1 of 1 : johngw_s_20140306_796.jpg

Trees need to be trimmed to 5'. Spring 2013

LM Start	0.17	Rating **	M	Issue No.	8
LM End	0.17	Issue Type +	Ma	Location *	LS
Category	Earthen Levee			GPS Latitude/Longitude	
				Start	End
Item	Trim / Thin Trees			38.724445 °	38.724445 °
				-121.806505 °	-121.806505 °
DWR ID	DWR_NA0021_01_s _ 2012_8				
Action/Comments					
Trim trees to at least five feet above ground level.

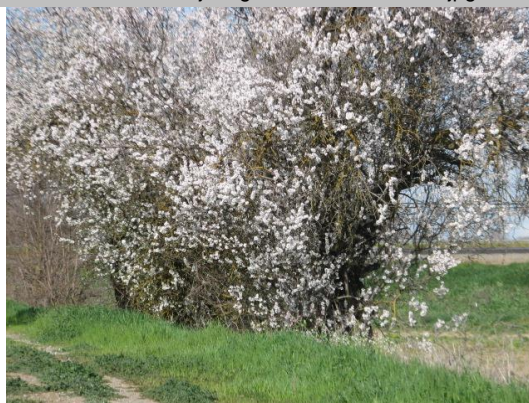
Photo 1 of 1 : johngw_s_20140306_797.jpg

Trees need to be trimmed to 5'. Spring 2013

LM Start	0.21	Rating **	M	Issue No.	9
LM End	0.21	Issue Type +	Ma	Location *	LS
Category	Earthen Levee			GPS Latitude/Longitude	
				Start	End
Item	Trim / Thin Trees			38.725022 °	38.725022 °
				-121.806478 °	-121.806478 °
DWR ID	DWR_NA0021_01_s _ 2012_9				
Action/Comments					
Trim trees to at least five feet above ground level.

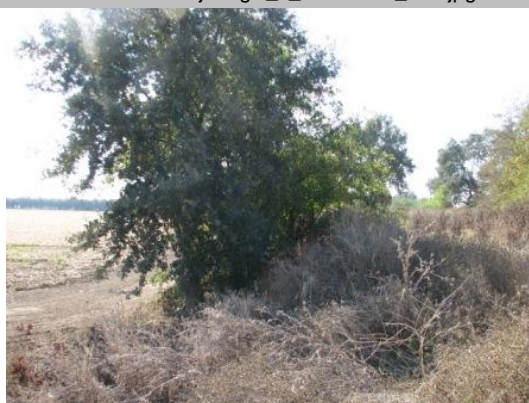
Photo 1 of 1 : johngw_s_20140306_798.jpg

The tree needs to be trimmed up. Photo taken fall of 2011.

LM Start	0.24	Rating **	M	Issue No.	10
LM End	0.24	Issue Type +	Ma	Location *	LS
Category	Earthen Levee			GPS Latitude/Longitude	
				Start	End
Item	Trim / Thin Trees			38.725427 °	38.725427 °
				-121.806470 °	-121.806470 °
DWR ID	DWR_NA0021_01_s _ 2012_10				
Action/Comments					
Trim trees to at least five feet above ground level.
